Medfield State Hospital, Medfield, Ma  
Cultural Arts Facility Feasibility Study  
Architectural Assessment

April 5, 2017

**DBVW**  
ARCHITECTS

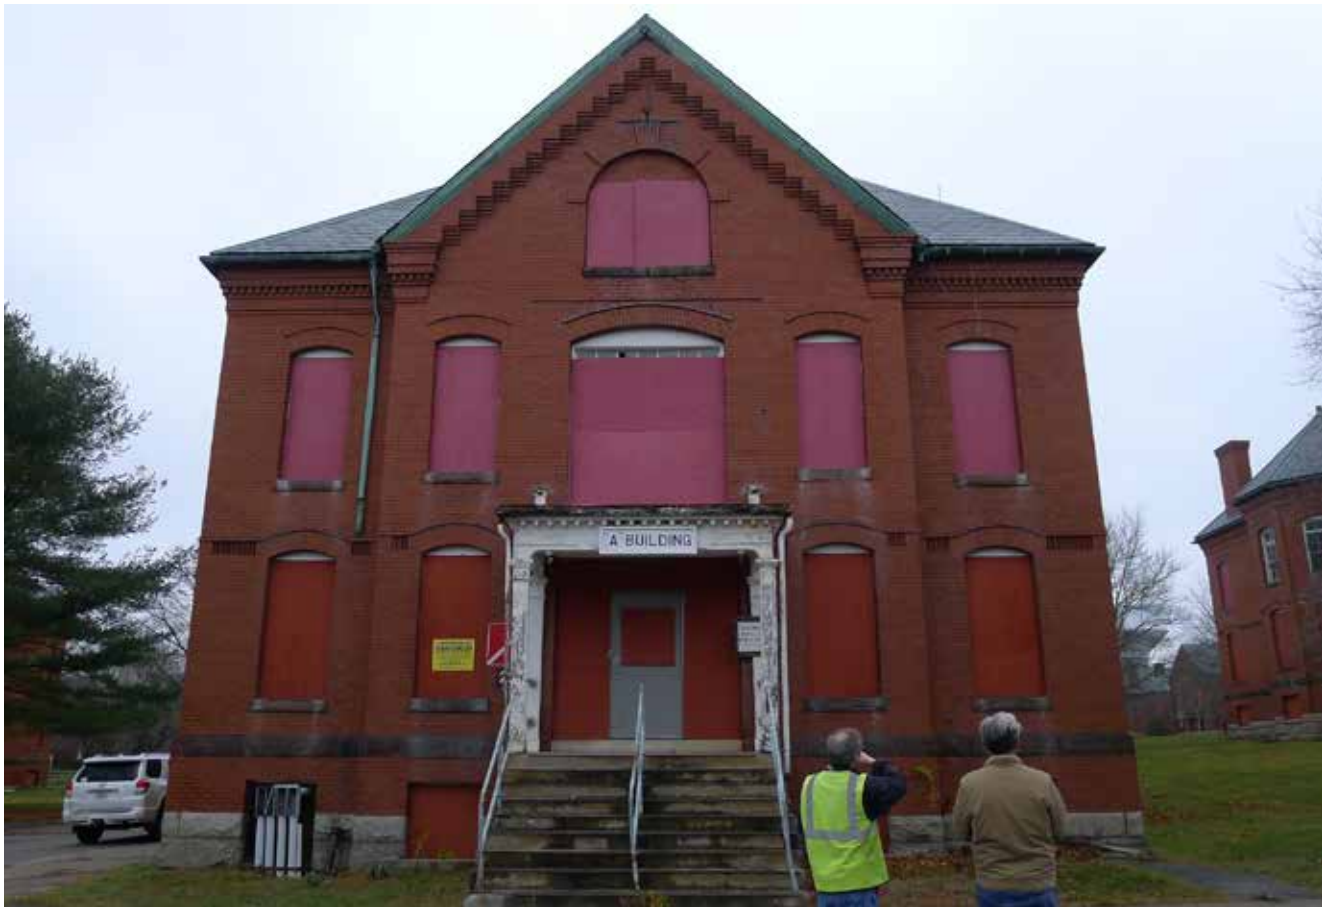
Figure 3. South elevation of building #22A Administration.

The elevated main entry portico on the South facade is intact, but is in need of significant repair. The original steps and rails have been replaced by historically inappropriate cast-in-place concrete steps and steel railings, both of which are in poor condition. On the West facade, there is another set of non-original, deteriorated concrete stairs, leading to a non-original egress door that serves as an exit from the main stairway. Below this stair, there is an areaway with cast-in-place concrete egress stairs leading from the basement level. On the North facade, a third set of non-original concrete stairs exists, but the original wood portico has been removed. On the East elevation, there is a non-original steel fire escape attached to the wall, connecting between third and second story windows.

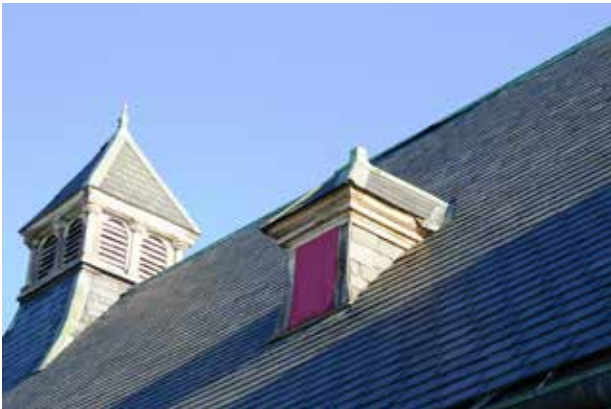
Figure 21. Slate roof, cupola and dormer

2.2 Exterior- Roof: The roof is clad in slate shingles, copper valley and ridge flashings, copper gutters and decorative gable cornice moldings, all of which appears to be original. Additionally, there is an original vented cupola with a decorative copper finial at the North end of the roof and a weather vane atop the large clock tower on the Southwest corner. Slate shingles are missing or replaced/patched in many areas, and many others appear to be loose. Based on evidence of substantial water infiltration at the valley between the East side of the clock tower and the South Gable, the copper flashing (and possibly roof shingles) appear to be damaged at this area. Copper gutters are somewhat

intact, though the condition could not be determined. Copper downspouts have been removed in many areas however, resulting in accelerated mortar deterioration at areas under gutter outlets. Dormers, cupola and clock tower faces all require carpentry repairs.

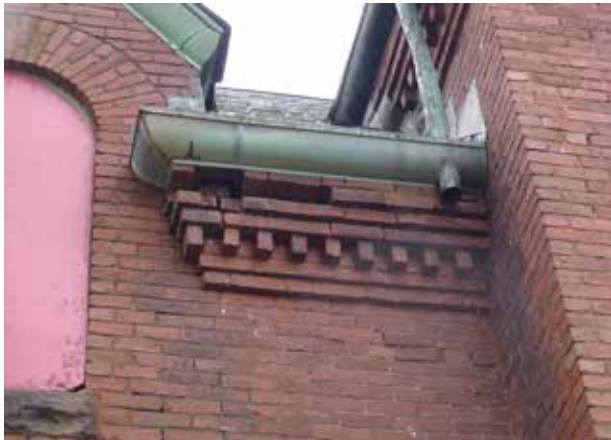
Figure 22. Missing and damaged masonry detailing; copper gutters

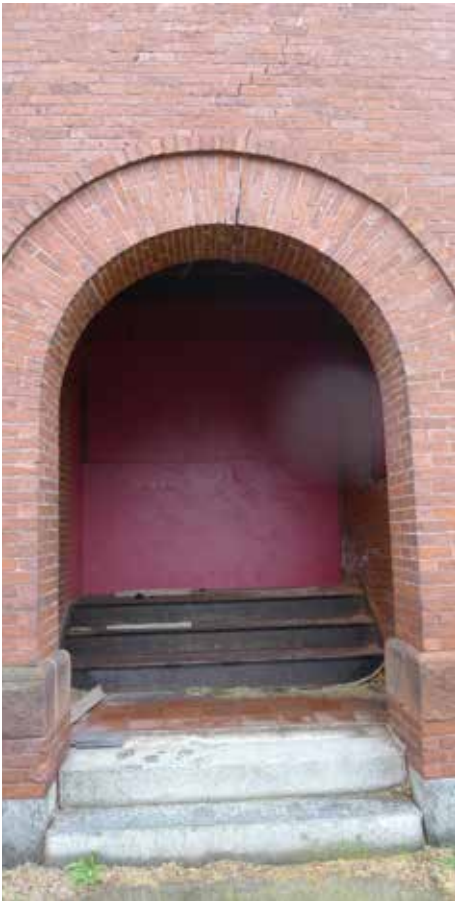
Figure 23. Recessed entry; settlement cracking above brick arch

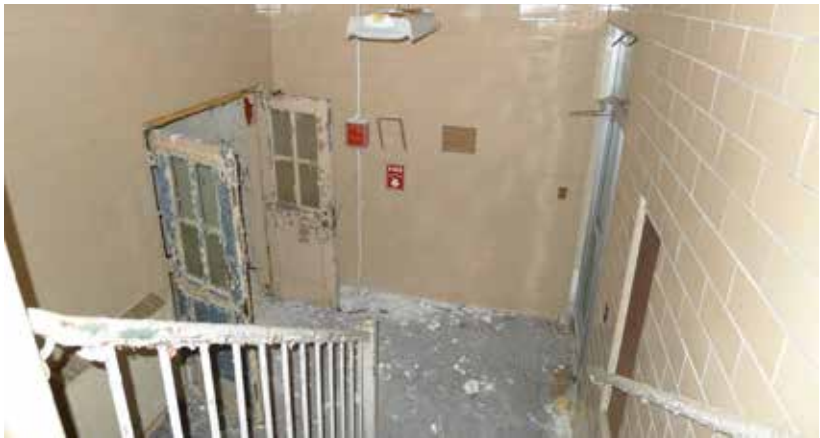
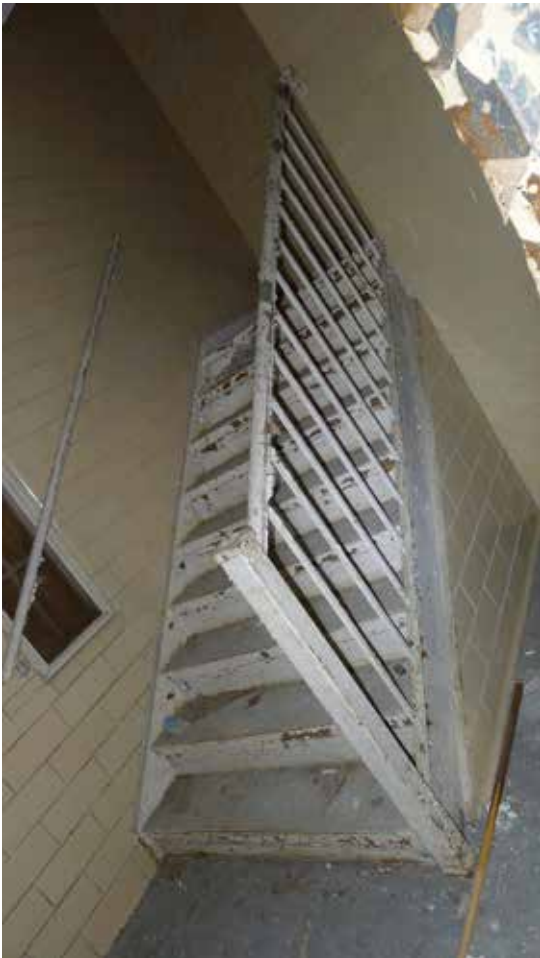
Figure 45. East stairway (non - original)

Figure 46. East stairway (non - original)

3.8 Interior - Stairs: There are stairways at each end of the central corridor. The wood stairway connecting all three levels on the West end appears to be original and in good condition. The steel-framed stairway at the East end appears to be a later addition and is also in good condition. This stairway only connects the first and second floors. The second means of egress from the basement at this end of the building is via an exterior areaway stair.

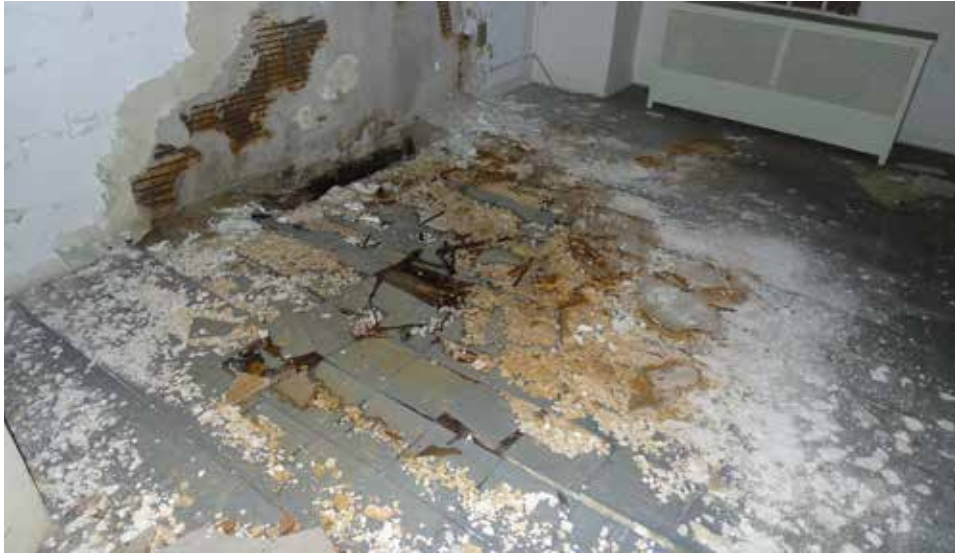
Figure 49. Water damage and deterioration from roof leak
